Current Site

The Ypsilanti Transit Center (YTC) was constructed in 1993 at 220 Pearl St. between N. Adams St. and N. Washington St. in downtown Ypsilanti.

Proposed Concepts

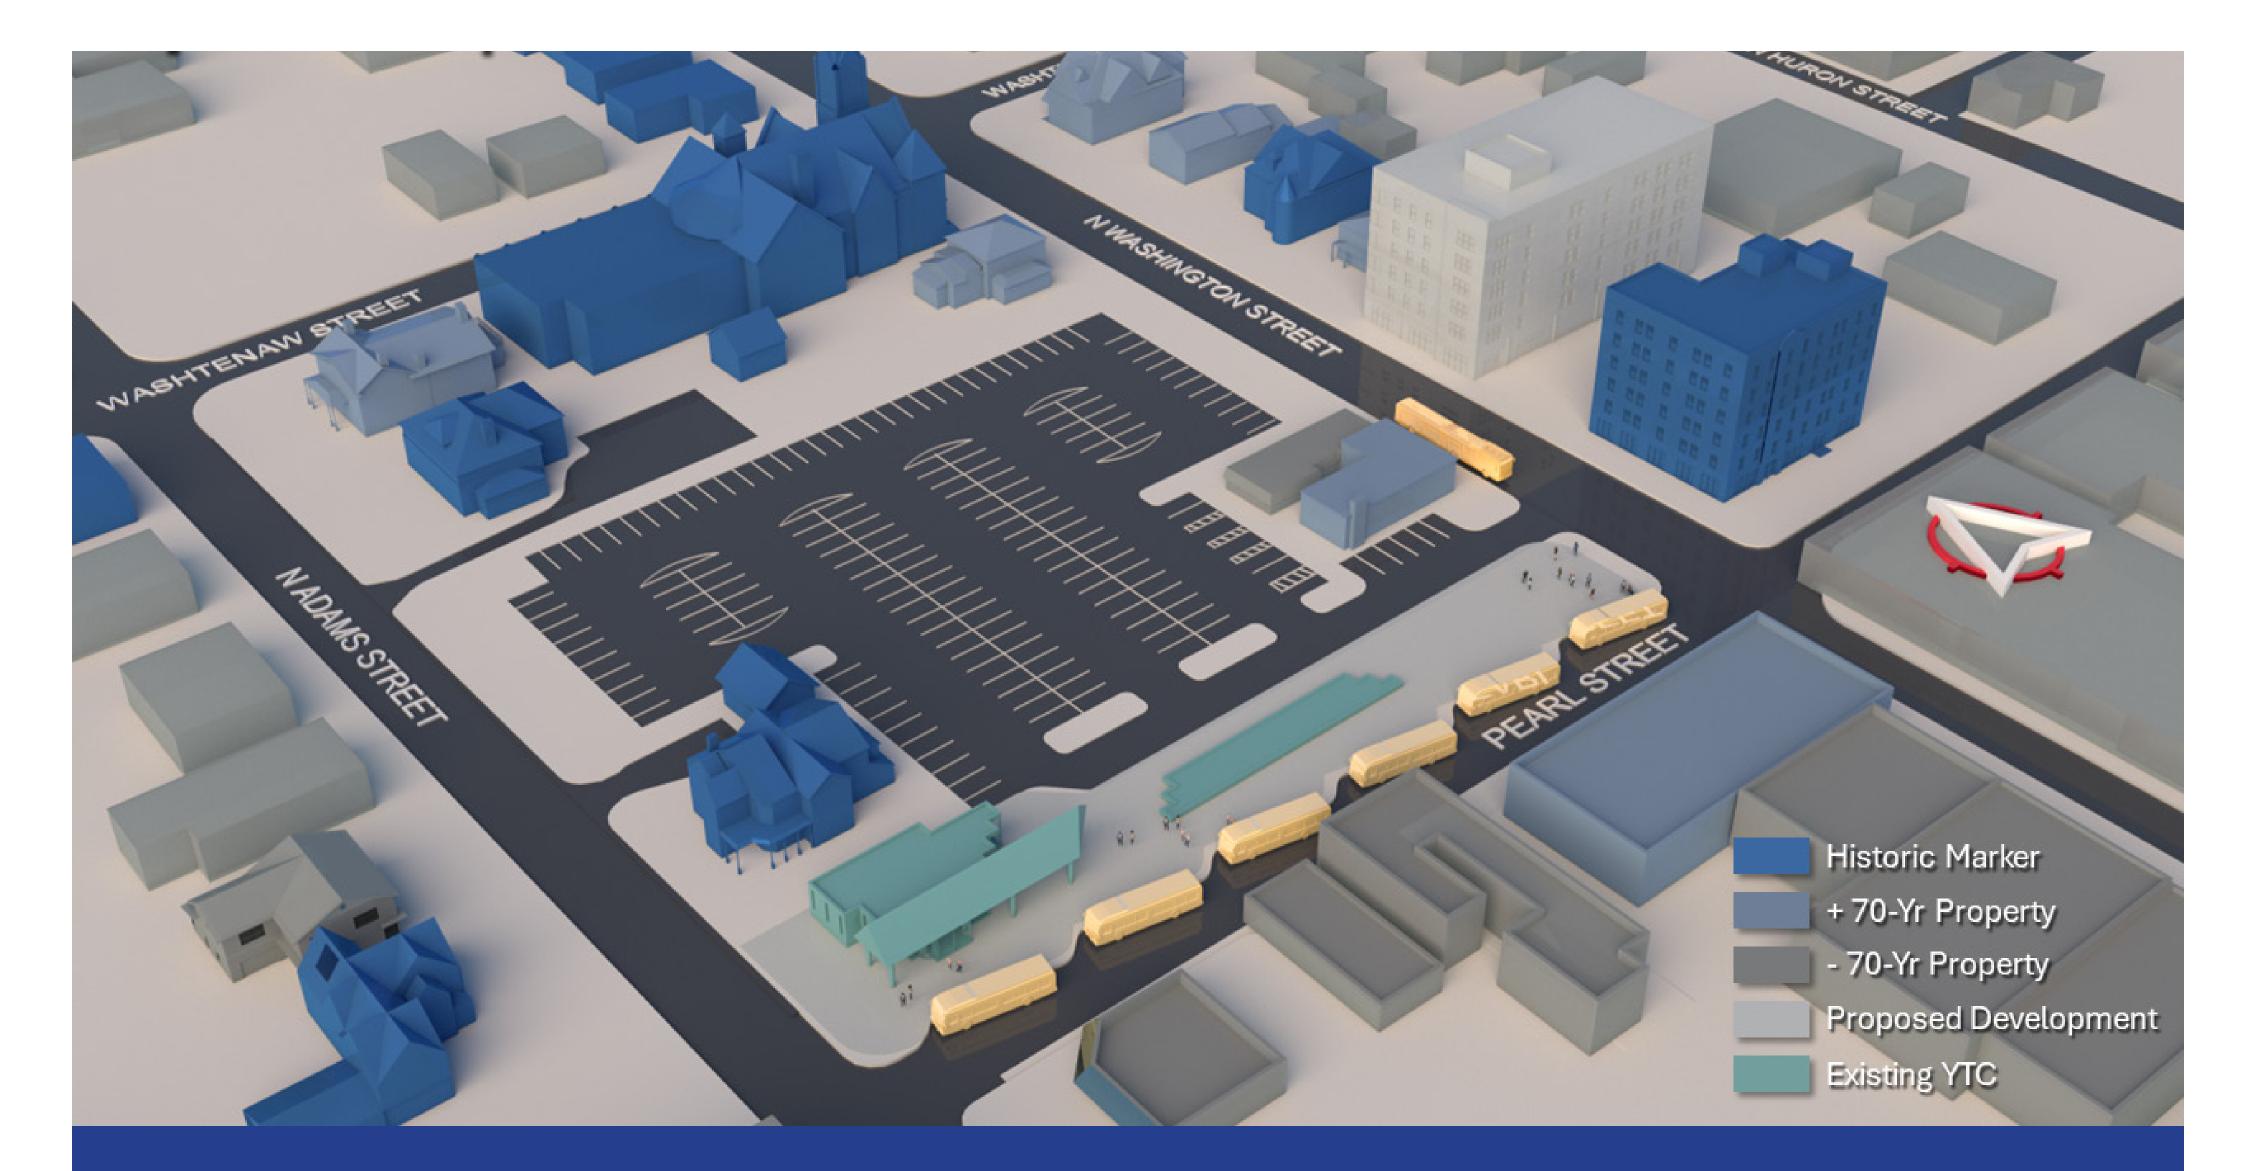
The current site includes:

- An enclosed facility of approximately 2,000 square feet in total.
 - Staff Areas:
 Driver's break room

Public Areas:

- Waiting area
- Private driver bathroom
- Security office
- Customer service desk
- Mechanical/IT room
- Six free-flow sawtooth bus bays along Pearl St.
- A platform area with benches, bike racks, trash receptacles, and route signage.
- Lay-by buses and shuttles also use on-street spaces on N. Washington Street.

- Public bathrooms
- Canopy area

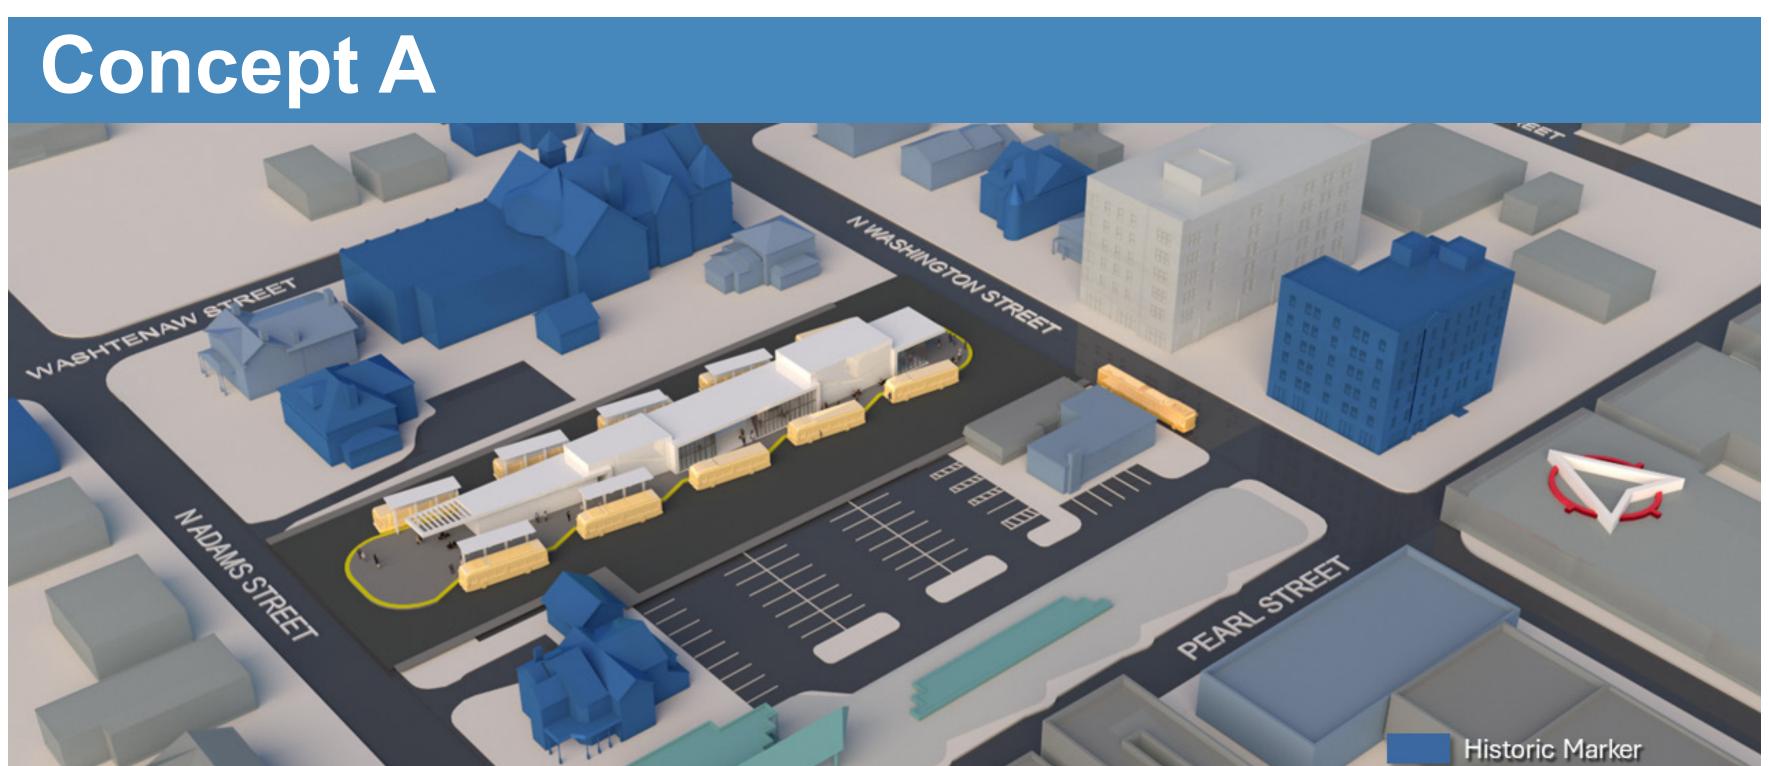
Characteristics

- 1. Located mid-block and reduced parking lot.
- 2. Existing adjacent buildings remain.
- 3. 10 bus bays on the platform (near the transit center).
- 4. Additional on-street bus parking away from YTC needed.
- 5. Narrow platform space.
- 6. Minimal disruption to current bus operations during construction staging.
- 7. Future development potential along Pearl St.

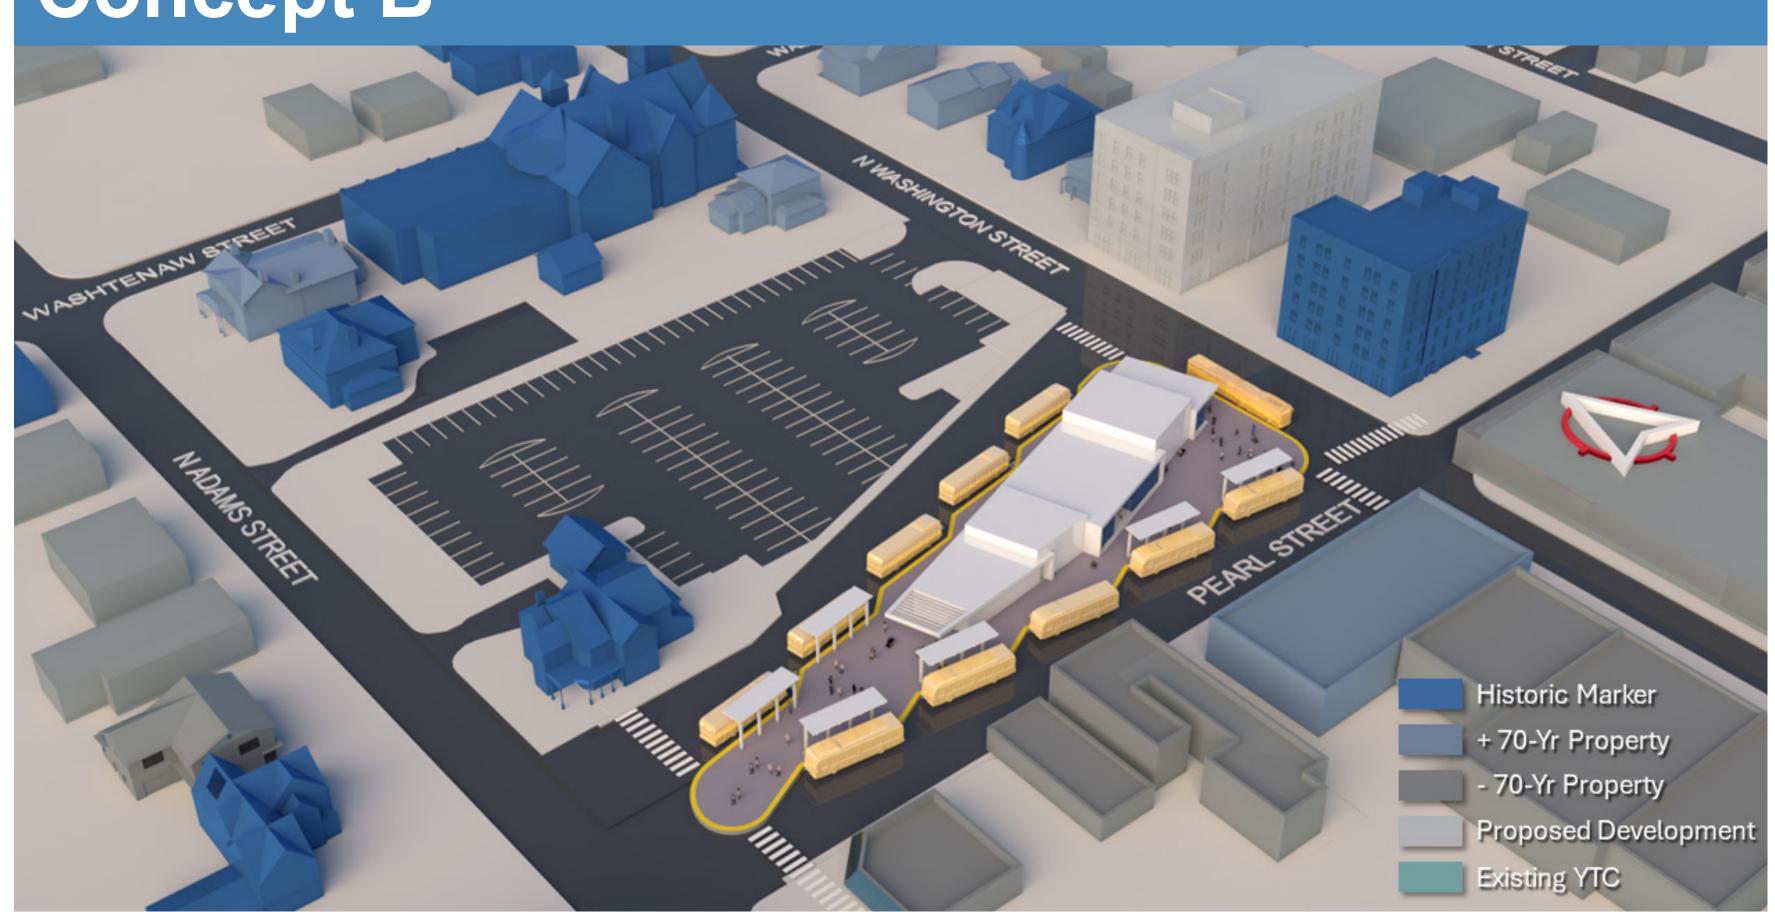
Characteristics

1. Located on Pearl St.

- 2. Removal of two east buildings and YTC.
- 3. 11 bus bays on the platform.

- 4. Wider platform space.
- 5. Operations impacted during construction staging.

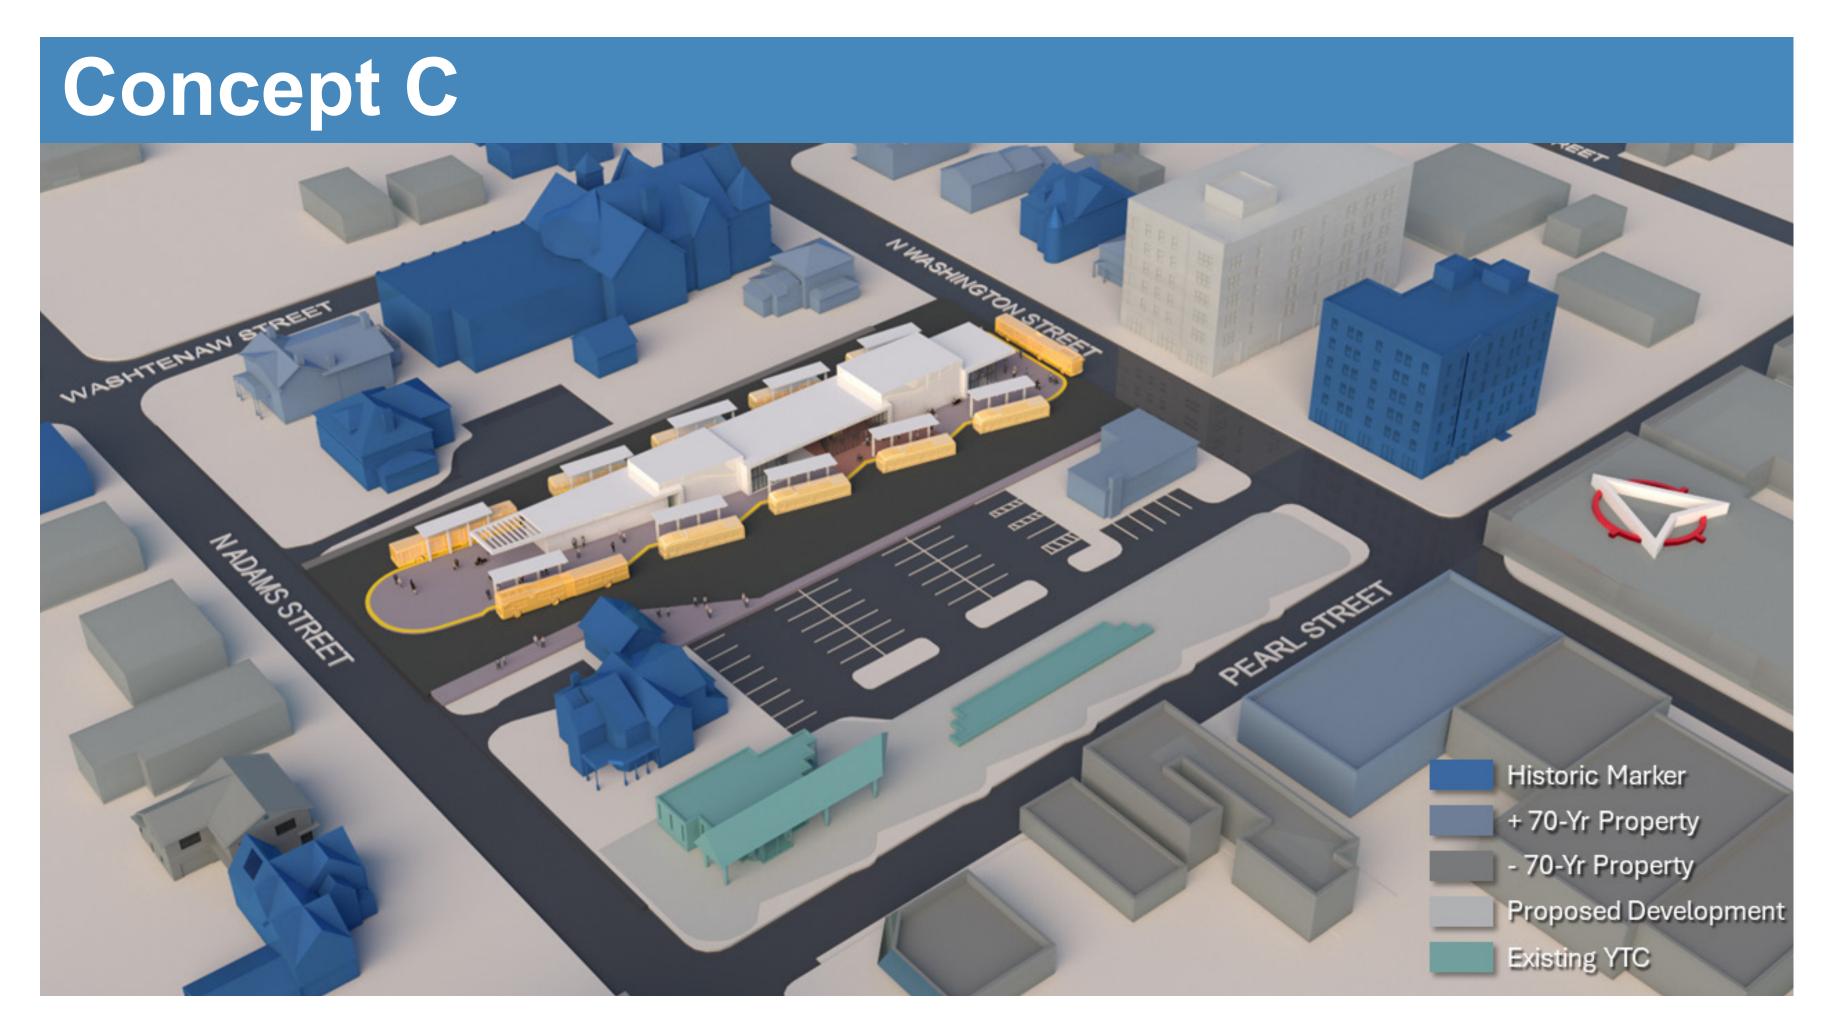
Characteristics

- 1. Located mid-block and reduced parking lot.
- 2. Removal of one east building.
- 3. 11 bus bays on the platform.

- 4. Minimal disruption to current bus operations during construction staging.
- 5. Future development potential along Pearl St.
